Limited Visual Dam Safety Inspections

OA00129

Waimanalo 60 MG Reservoir

Oahu, Hawaii

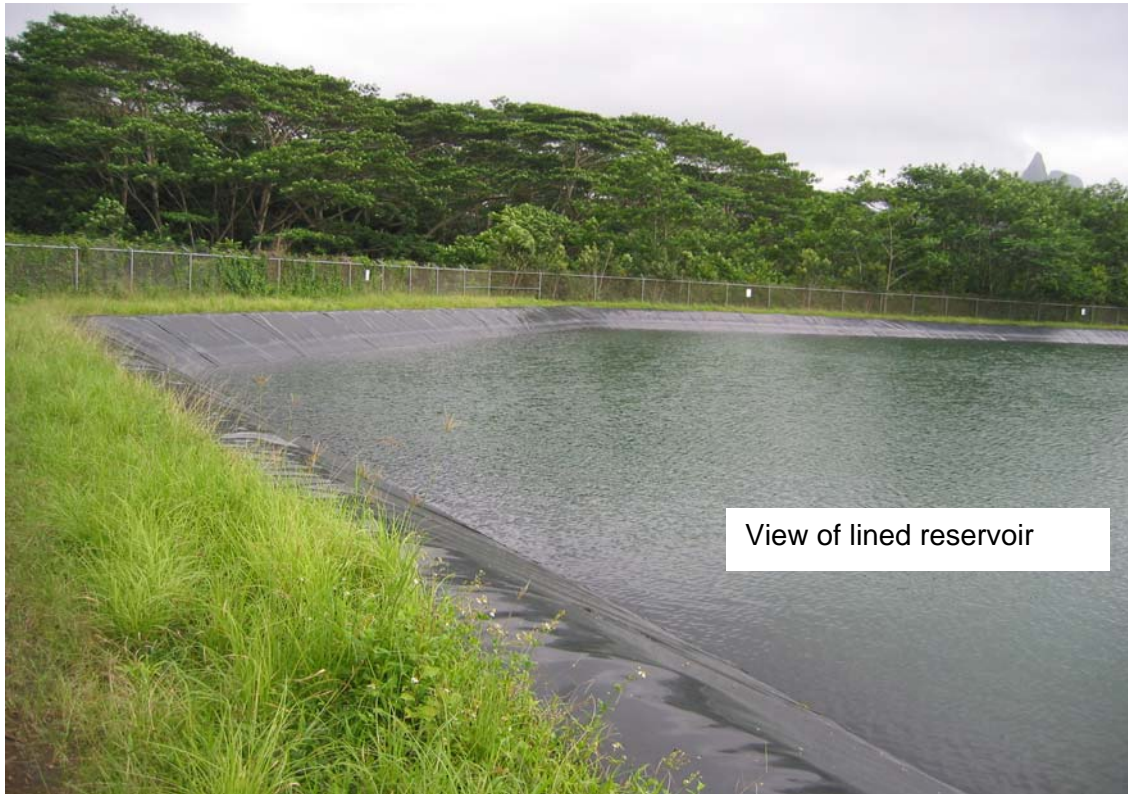
View of lined reservoir

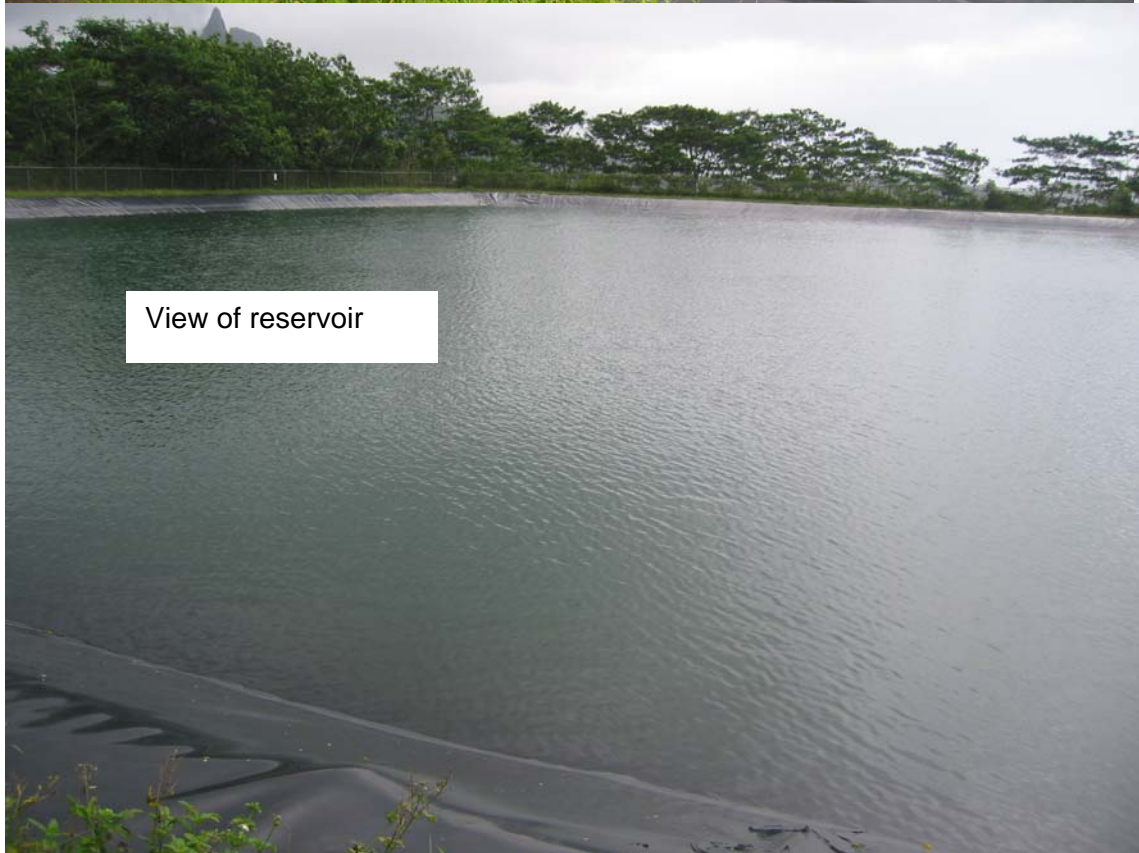
View of reservoir

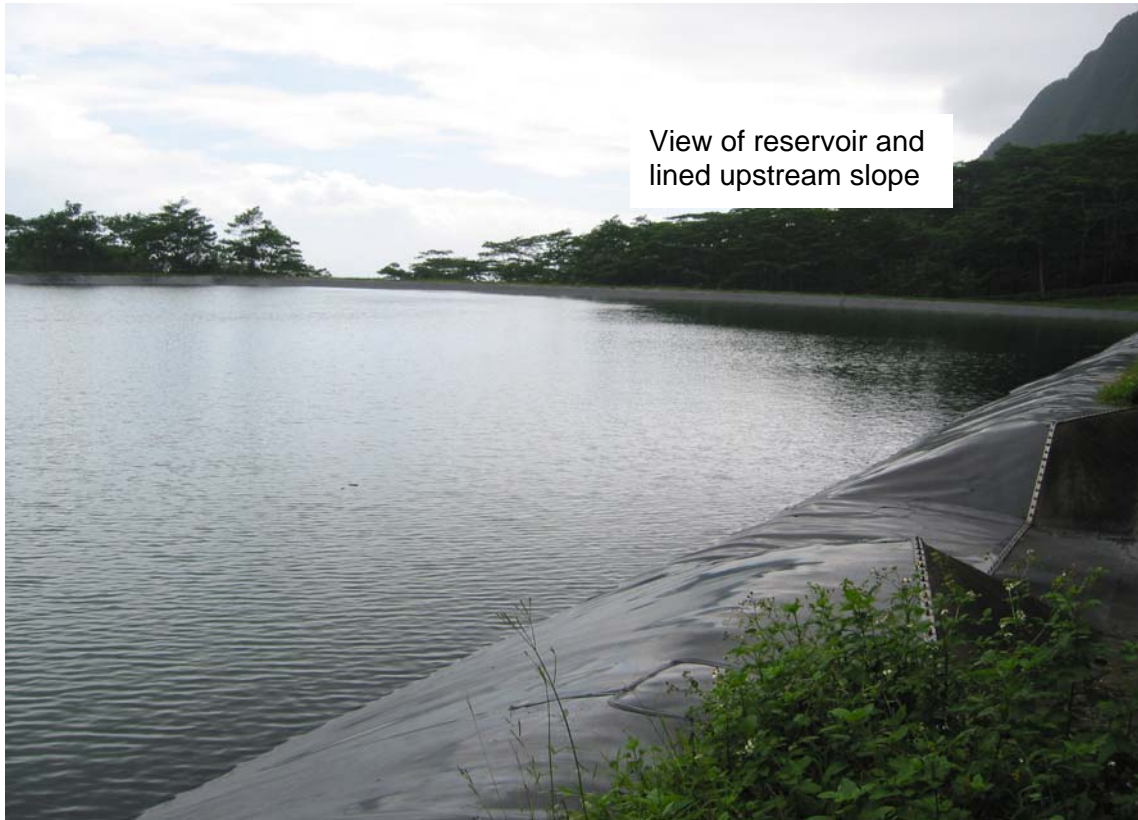
The slope and reservoir is lined with 60 mil HDPE liner. The existing surface is not visible. Erosions were not observed, the slope was not entirely visible.

View of reservoir and
lined upstream slope

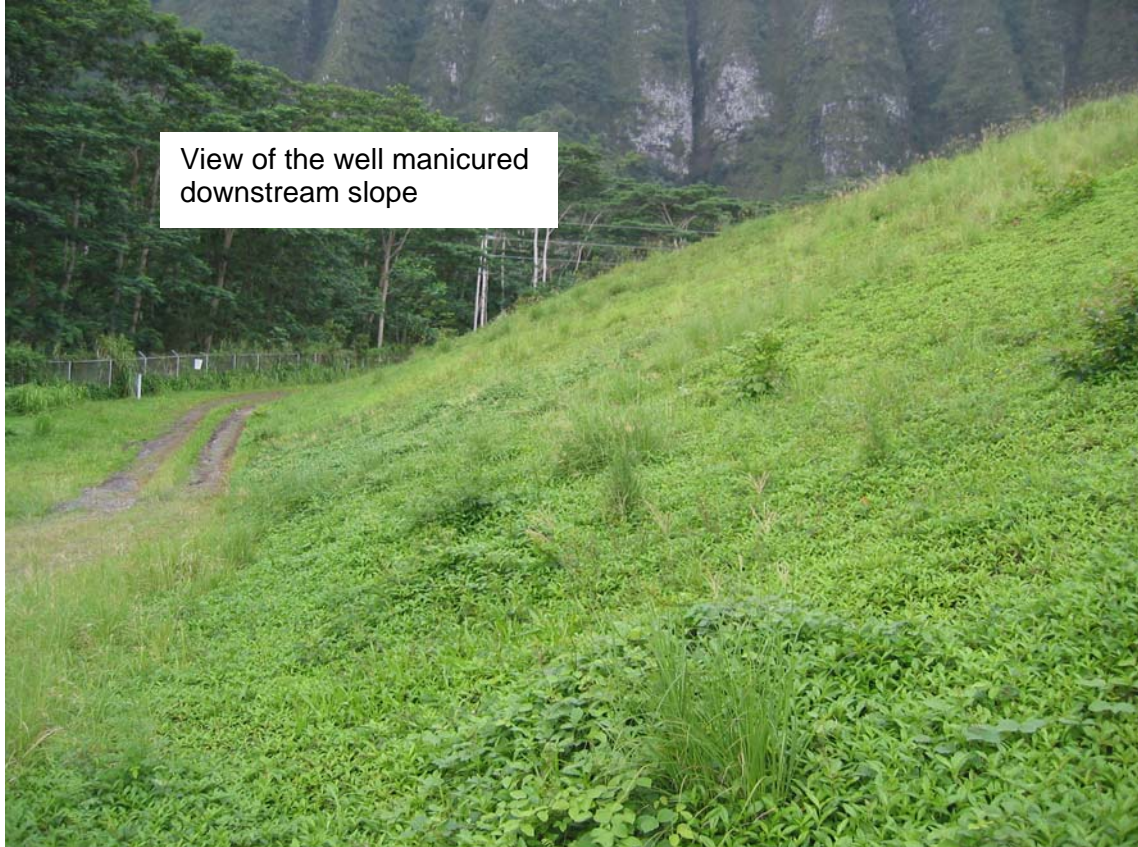
View of the well manicured
downstream slope

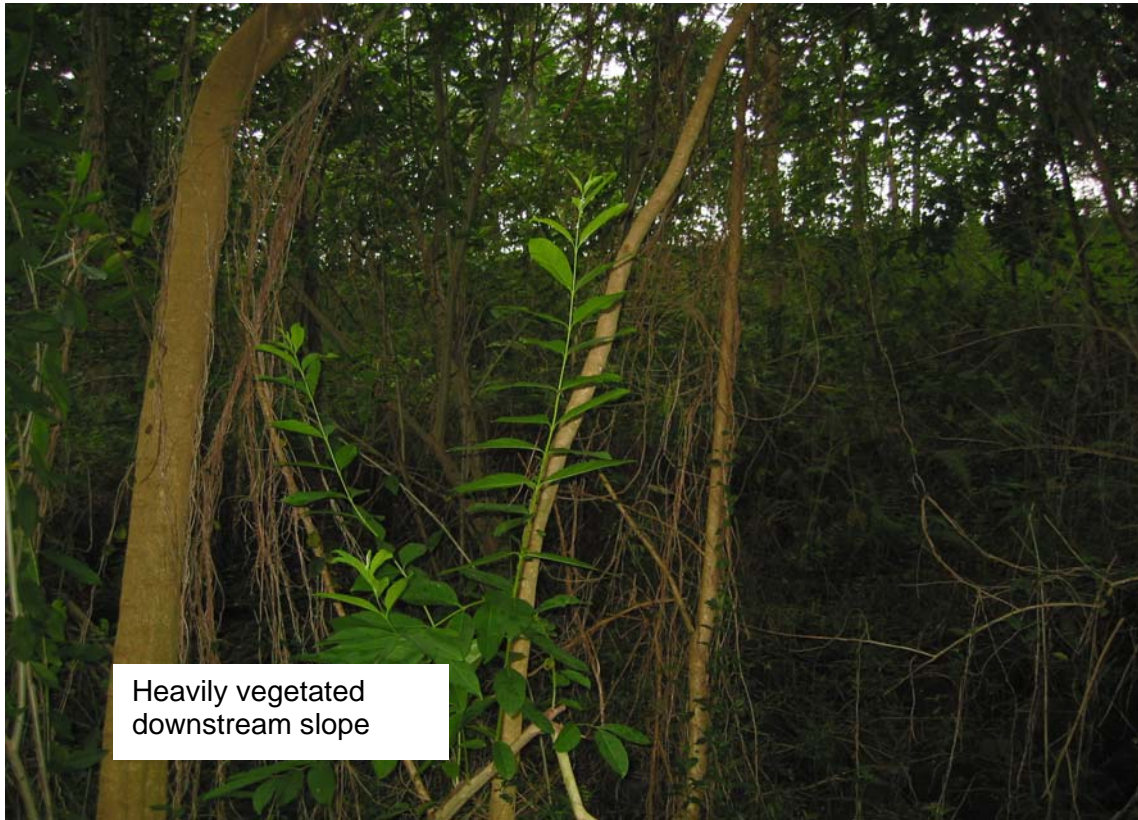
Vegetation was observed on the downstream slope. The majority of the vegetation was bushes with tall grass and woody trees.

Heavily vegetated
downstream slope

- a. The downstream slope was not fully inspected.
- b. The downstream slope appeared to be in fair to poor condition and requires corrective action.
- c. Clear high vegetation and maintain low to enable easy visual inspection.
- d. Tree(s) were observed on the downstream slope. Trees have been identified as the probably cause of piping failures, and can possibly cause severe damage to the embankment if they are uprooted during a high winds. Corrective action is required to remove the tree hazards from the dam. Acceptable remedies include removal of the tree and its root structure down to a 2" diameter and reconstructing the damaged embankment section. All repair work shall be accomplished as per the requirements of licensed geotechnical or structural engineer. Routinely monitor the damaged area for signs of settlement and seepage.

Recommend all trees be removed from the downstream slope of the embankment so a more thorough inspection can be performed.

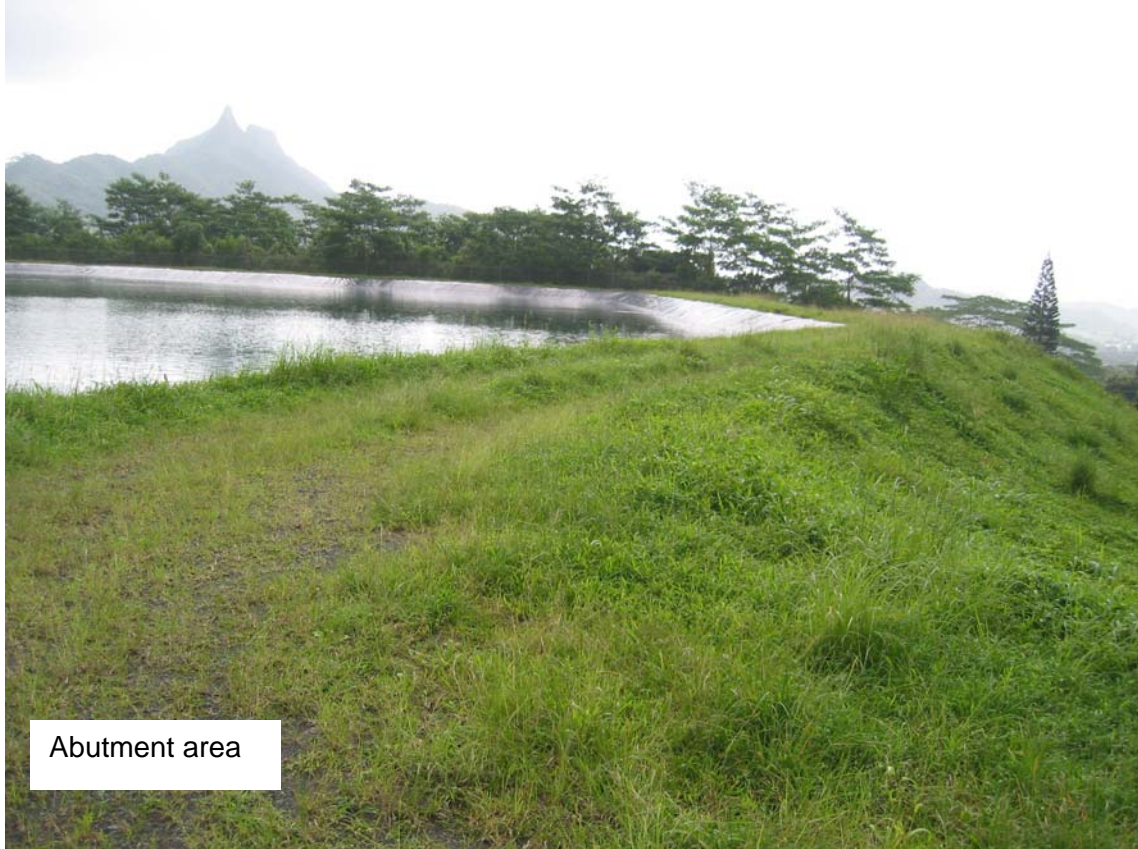
- a. The toe was not fully inspected.
- b. The abutments/toe appeared to be in fair to poor condition and requires corrective action.
- c. The abutment/toe area was not visible due to high grass and bush vegetation. Clear high vegetation and maintain low to enable easy visual inspection.

Abutment area

- d. Tree(s) were observed along the abutment/toe. Trees have been identified as the probably cause of piping failures, and can possibly cause severe damage to the embankment if they are uprooted during a high winds. Corrective action is required to remove the tree hazards from the dam. Acceptable remedies include removal of the tree and its root structure down to a 2" diameter and reconstructing the damaged embankment section. All repair work shall be accomplished as per the requirements of licensed geotechnical or structural engineer. Routinely monitor the damaged area for signs of settlement and seepage.

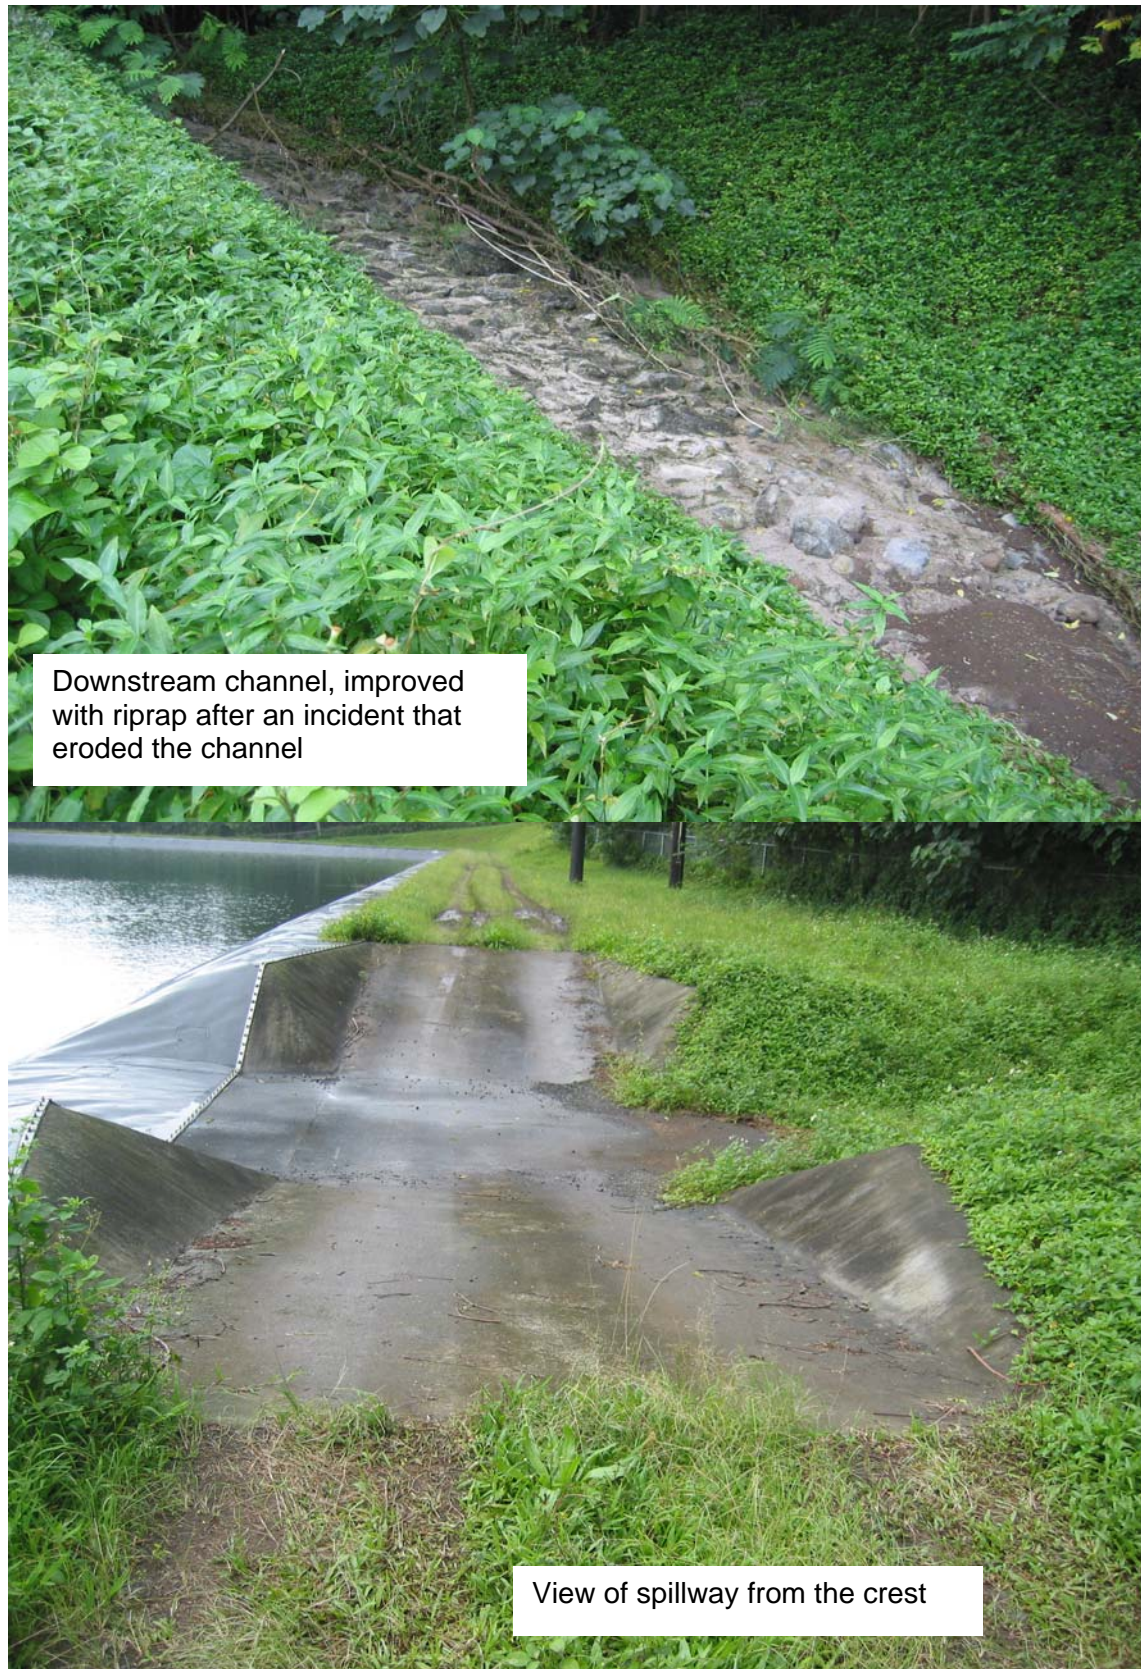
Modifications / Improvements: The downstream slope was repaired after it partially failed according to Doug Towes, NRCS. Also, the downstream channel was repaired and lined with riprap for protection after it was deeply scoured during a past sizable storm event. According to staff personnel, the only rainfall that contributes to the inflows is from the surface area of the reservoir.

Downstream channel, improved with riprap after an incident that eroded the channel

View of spillway from the crest

- a. The downstream channel was not fully inspected.
- b. The downstream channel appeared to be in fair to poor condition and requires corrective action.
- c. Clear trees within the channel.

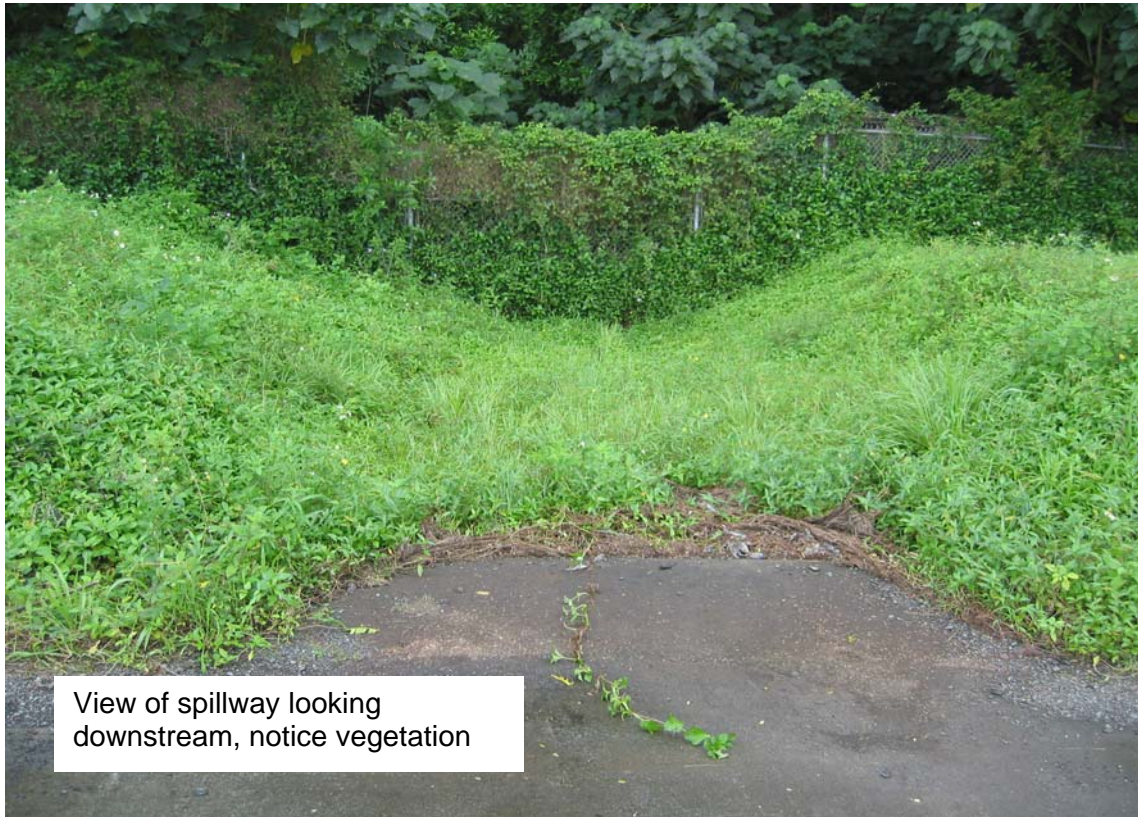
View of spillway looking downstream, notice vegetation

- a. The Spillway appeared to be in fair to poor condition and requires corrective action.
- b. The spillway downstream was partially blocked by vegetation. Clear approach.
- c. Unclear if spillway is adequately sized. Spillway should pass the probable maximum flood. Verify spillway capacity and take corrective action as required.

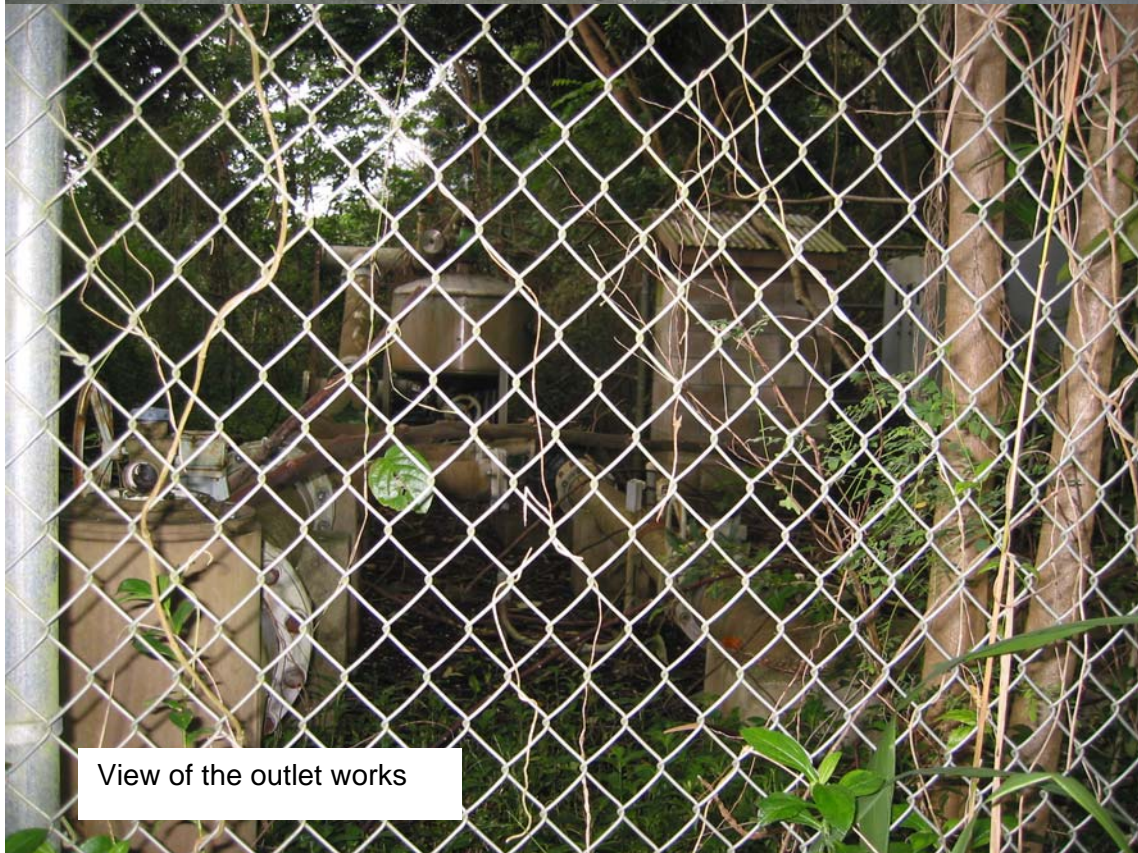
View of the outlet works
